## Longboat Key Roofing Traces Persistent Leak to Wall Flashing

SARASOTA, FL - August 27, 2026 -

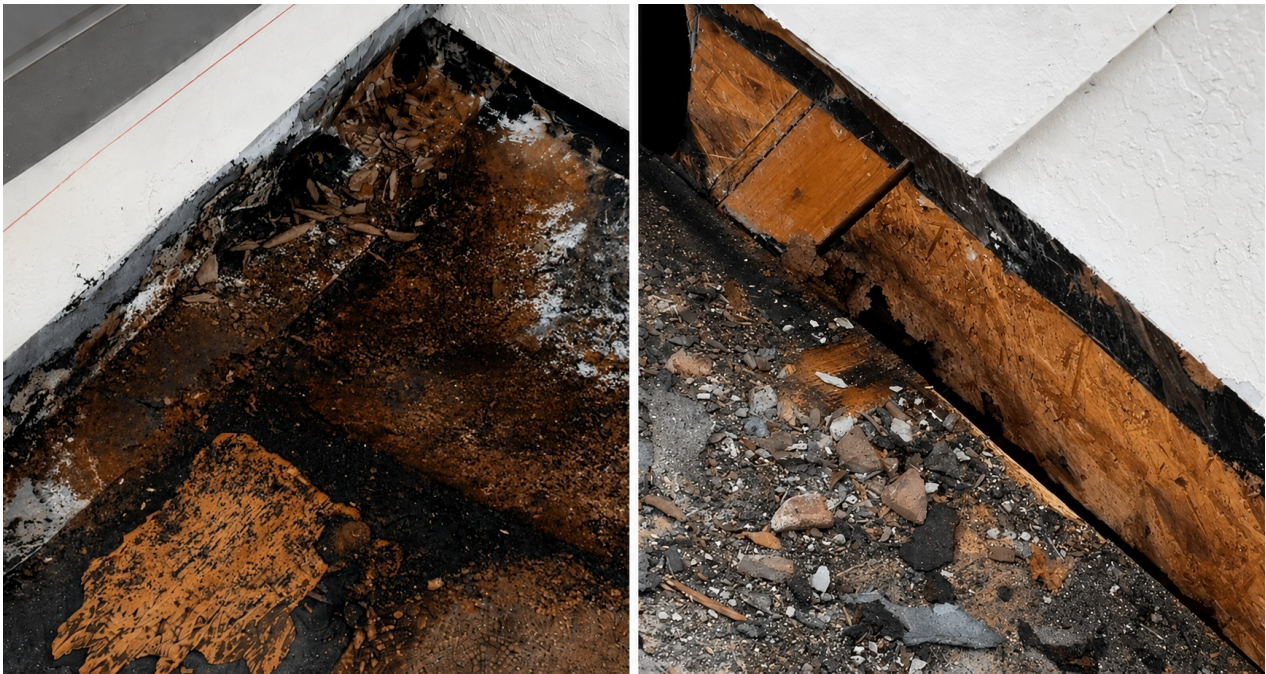
By the time Longboat Key Roofing became the fourth company involved, previous repair attempts had included applying sealant and waterproofing over heavily rusted and deteriorated flashing around the tile roof and chimney. The leak continued, leading the contractor to investigate the concealed portion of the assembly rather than make another surface repair.

During the July 21 roof inspection, the contractor identified heavily corroded flashing extending into the wall assembly near the chimney. After the deteriorated flashing was removed, rotted wood and large cracks were exposed behind it, providing additional evidence of prolonged moisture intrusion.

Peel said a concealed flashing problem can change the scope of a repair. Correcting it may require opening a portion of the wall, removing deteriorated flashing, replacing damaged wood where necessary, restoring the waterproofing and installing new flashing before the exterior finish is rebuilt.

On stucco homes, that process can involve separate stages. Peel explained that after the roofing, wood and waterproofing work is completed, the affected wall area may require a scratch coat followed by a finish coat to restore the exterior surface.
